The Performance of House Foundations in the Canterbury Earthquakes

Master of Engineering in Civil Engineering

Duncan Henderson

August, 2013

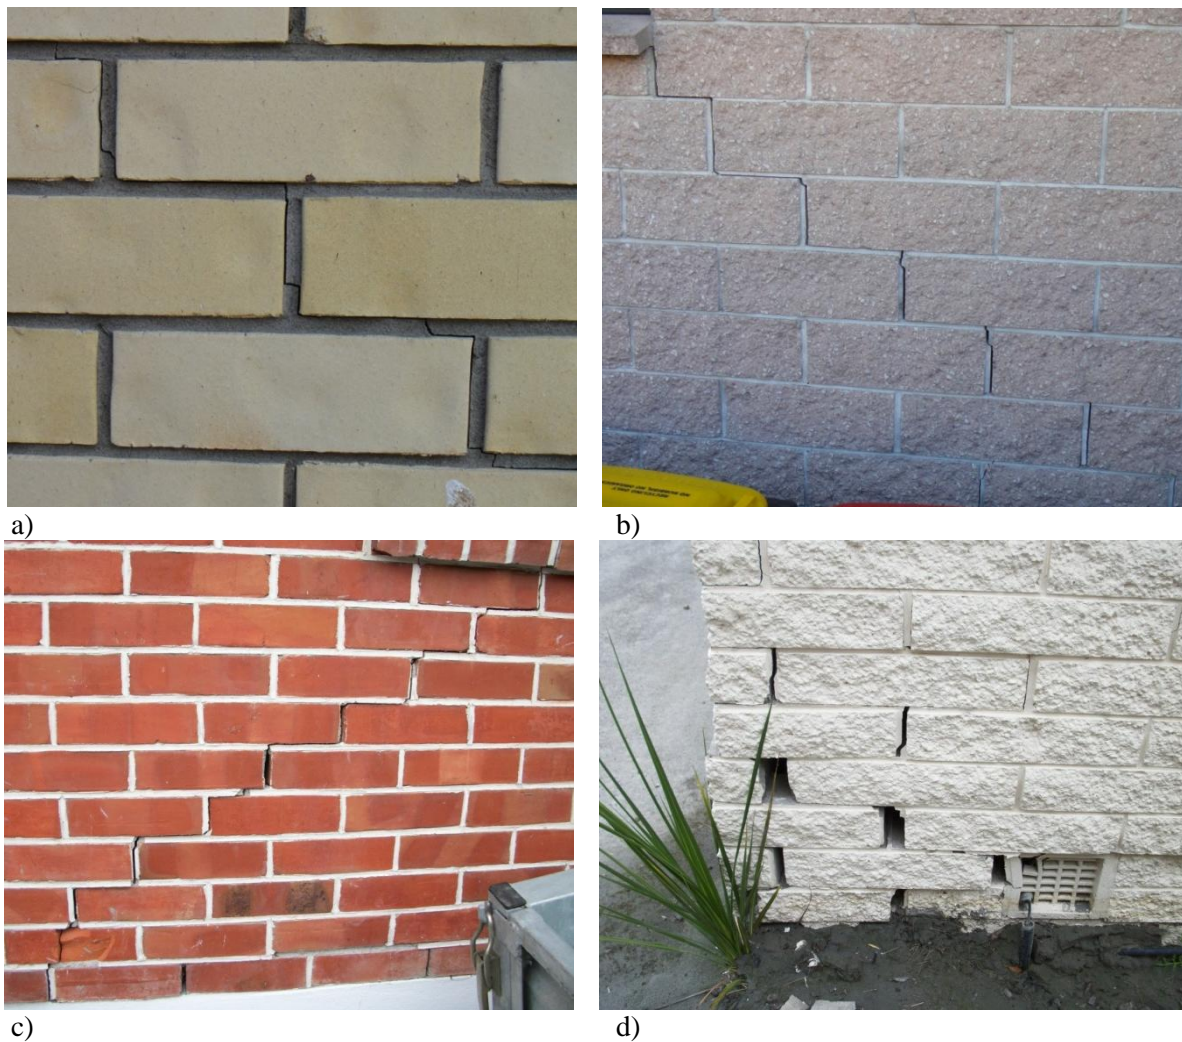
The most common exterior damage was to brick claddings, shown in Figure 3.4. Cracks were either vertical, horizontal or diagonal, and almost always through the mortar joints between bricks. Cracking through a brick, as shown in Figure 3.4.(c) was very rare. Cracks were anything from hairline to more than 10-20mm in width. In some cases whole corners were separated, as shown in Figure 3.4.(d).

Figure 3.4. Damage to brick cladding, a) low, b) moderate, c) high and d) corner separation and collapse.

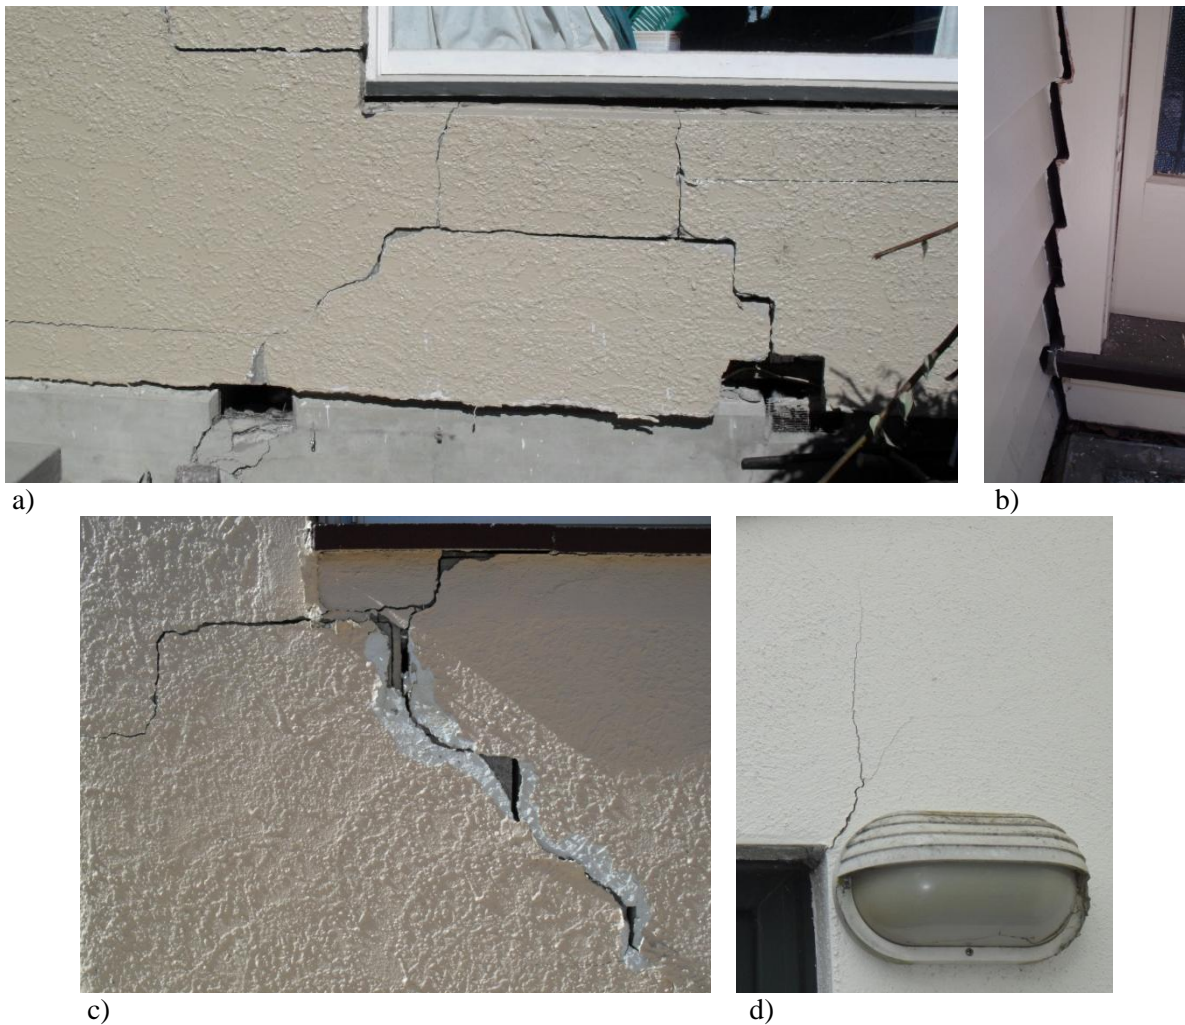
Figure 3.5.(a) and (c) show damage to concrete block cladding overlain by stucco. Damage to this is similar to that for brick cladding, with cracking through the mortar joints between concrete blocks, causing similar cracking patterns in the stucco covering. These images show a severe level of damage, with some separation and collapse of the cladding. Minor damage to stucco cladding, as shown in Figure 3.5.(d), is seen as minor hairline to 5mm cracks in the stucco, often at the corners of openings such as door and window frames.

Figure 3.5. Damage to claddings, a) severe damage and partial collapse of stucco/concrete block cladding, b) high damage separation between weatherboard and door due to structural damage, c) moderate cracking in stucco/concrete block veneer and d) minor cracking in stucco veneer.

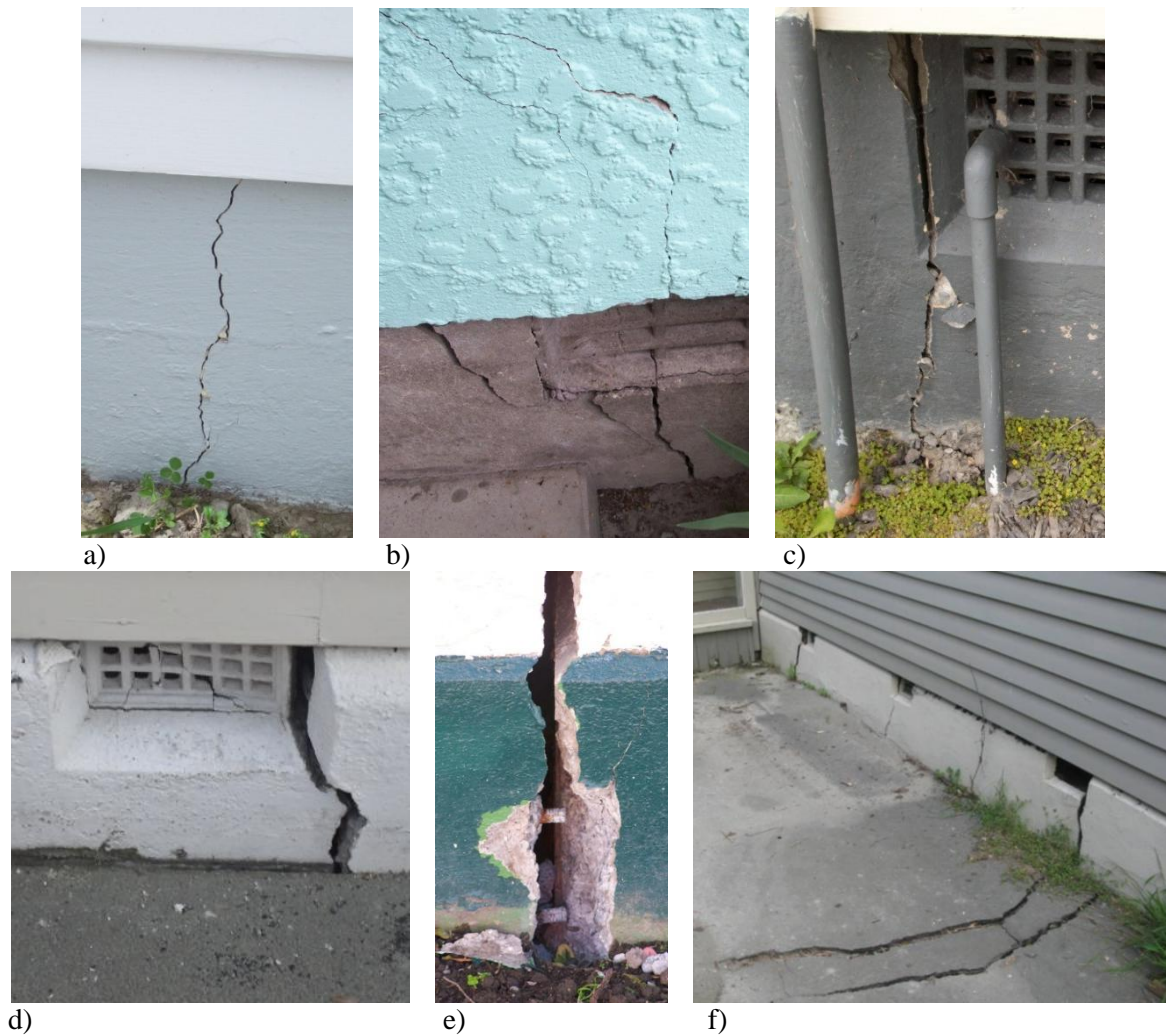
Damage to concrete perimeter foundations caused by liquefaction ranged from minor hairline and 1-2mm cracking, as shown in Figure 3.10.(a) to much larger cracks with anywhere from 50-100mm of separation and significant lateral offsets, as shown in Figure 3.10.(d) and (e). The most common place for cracking to occur in concrete perimeter foundations is at the air vents, as shown in Figure 3.10.(b), (c), (d) and (f). This is to be expected, as these are reduced sections with lower strength.

Figure 3.10. Cracking in concrete perimeter wall, a) low, b) and c) low-moderate, d) high, e) severe showing exposed reinforcing and f) multiple foundation cracks at air vents.

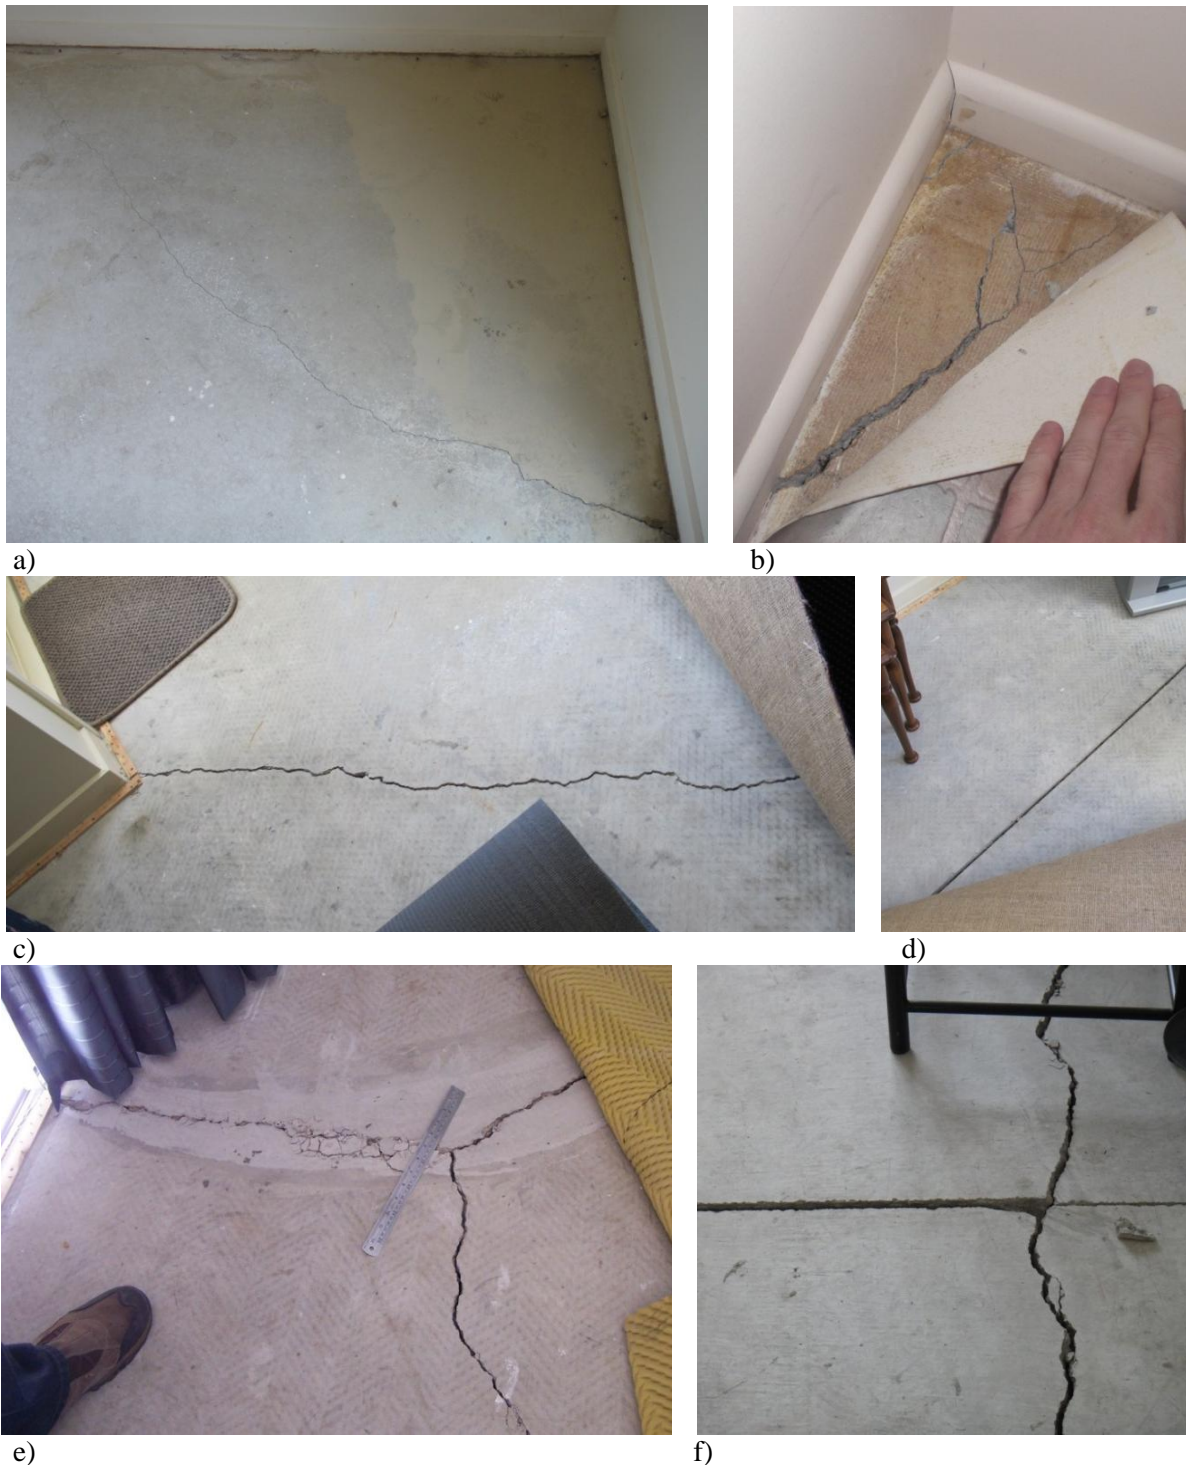
Figure 3.13. Cracking in slab-on-grade floors, a) minor crack, b) and c) moderate cracking, d) moderate separation between slab sections, e) and f) moderate-high cracking and separation in slab.

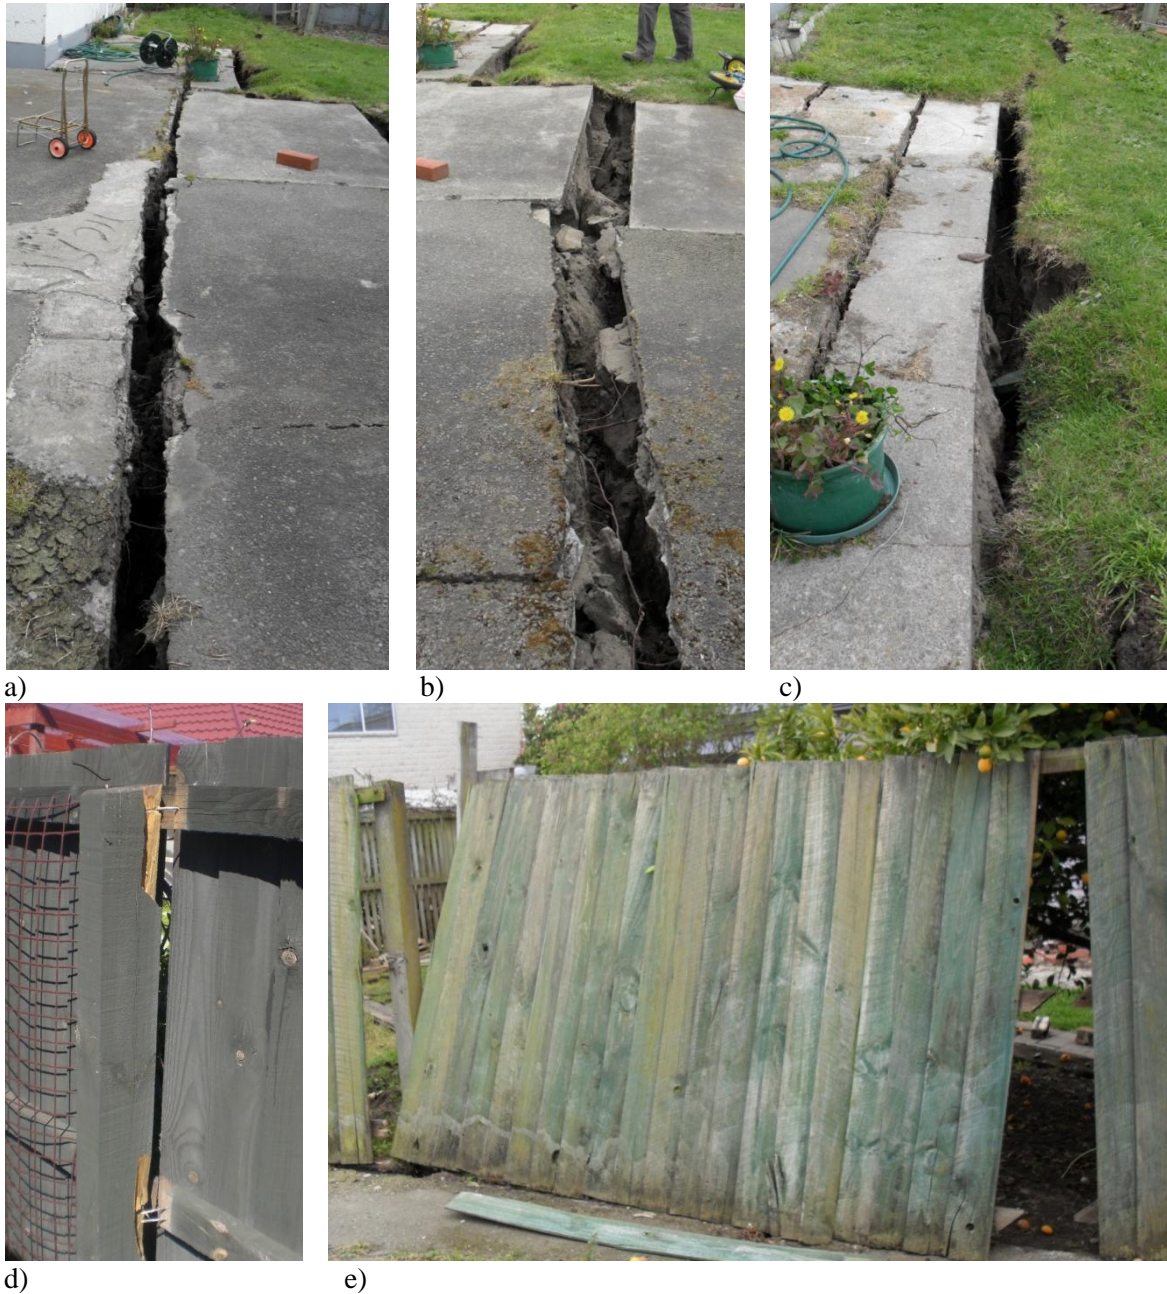
There was less damage to fencing but some was caused by liquefaction ejecta pushing up and distorting the fencing or lateral spreading ripping it apart (Figure 3.19.(d) and (e)).

Figure 3.19. Damage to surroundings, a), b) and c) severe damage to paving and ground due to large lateral spreading cracks, f) moderate damage to fence and g) high-severe damage to fence.

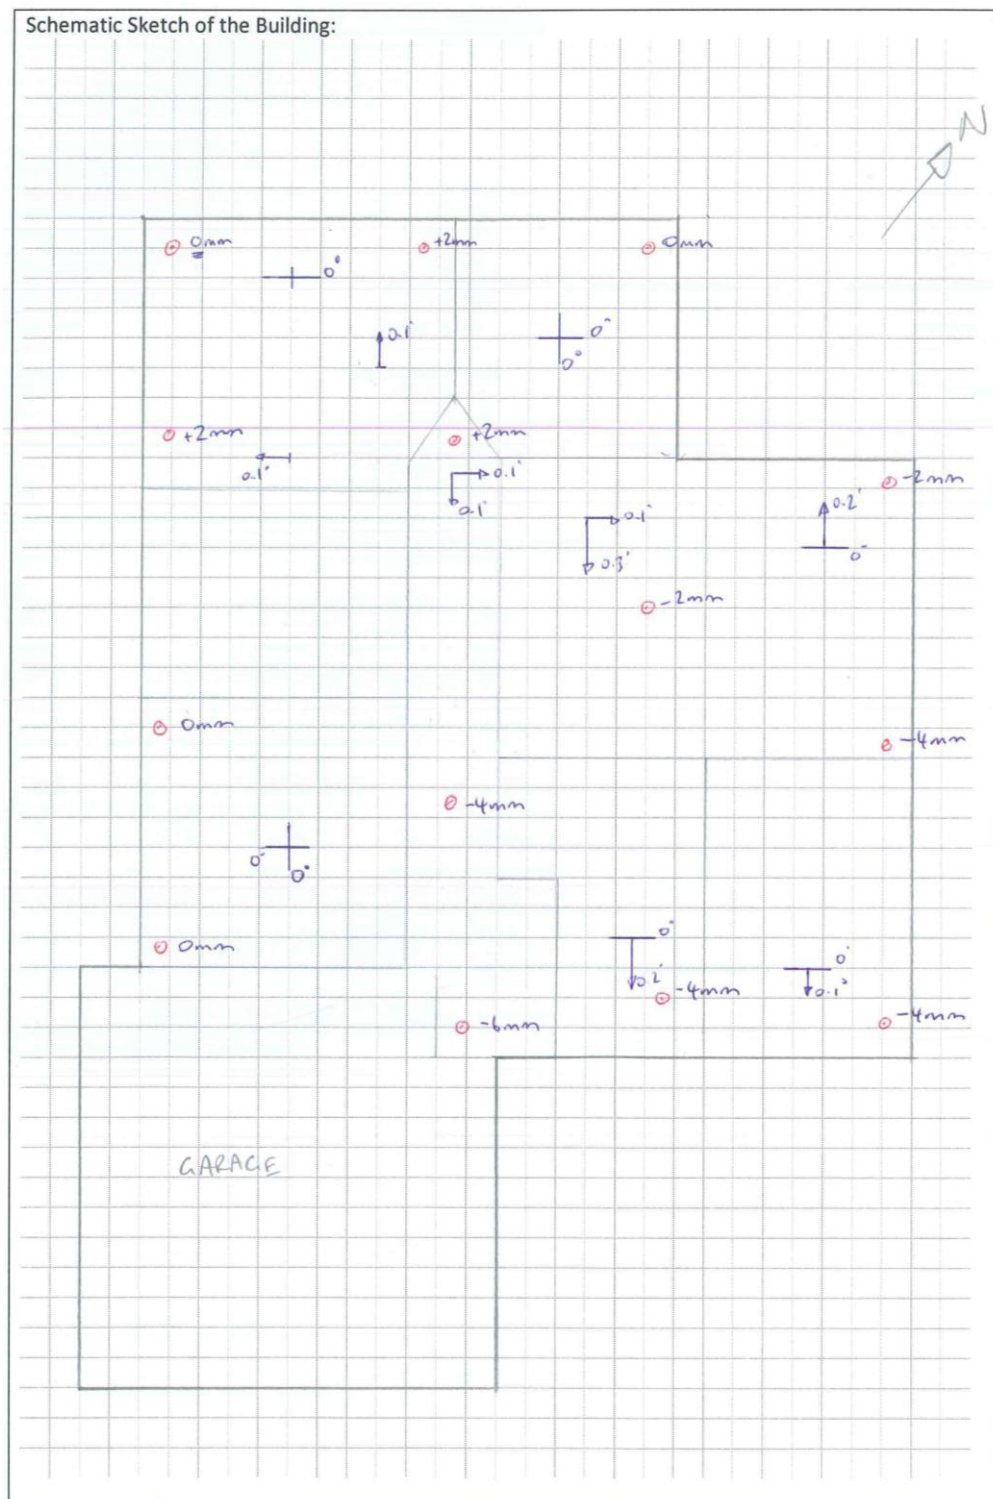
They can also be due to changing floor coverings between measurements or instrumental inaccuracies, as noted in Table 4.3. The combination of these three sources of measurement inaccuracies give instrument readings of $0.1\text{--}0.2^\circ$ on the smart-level, and $\pm 5\text{mm}$ on the Zip Level (see Figure 4.16). Houses given this deformation mode are always assigned a damage rating of ‘none’, and generally show no or low damage to their superstructures and foundations.

Figure 4.16. Example floor plan for a house with construction tolerance movements.

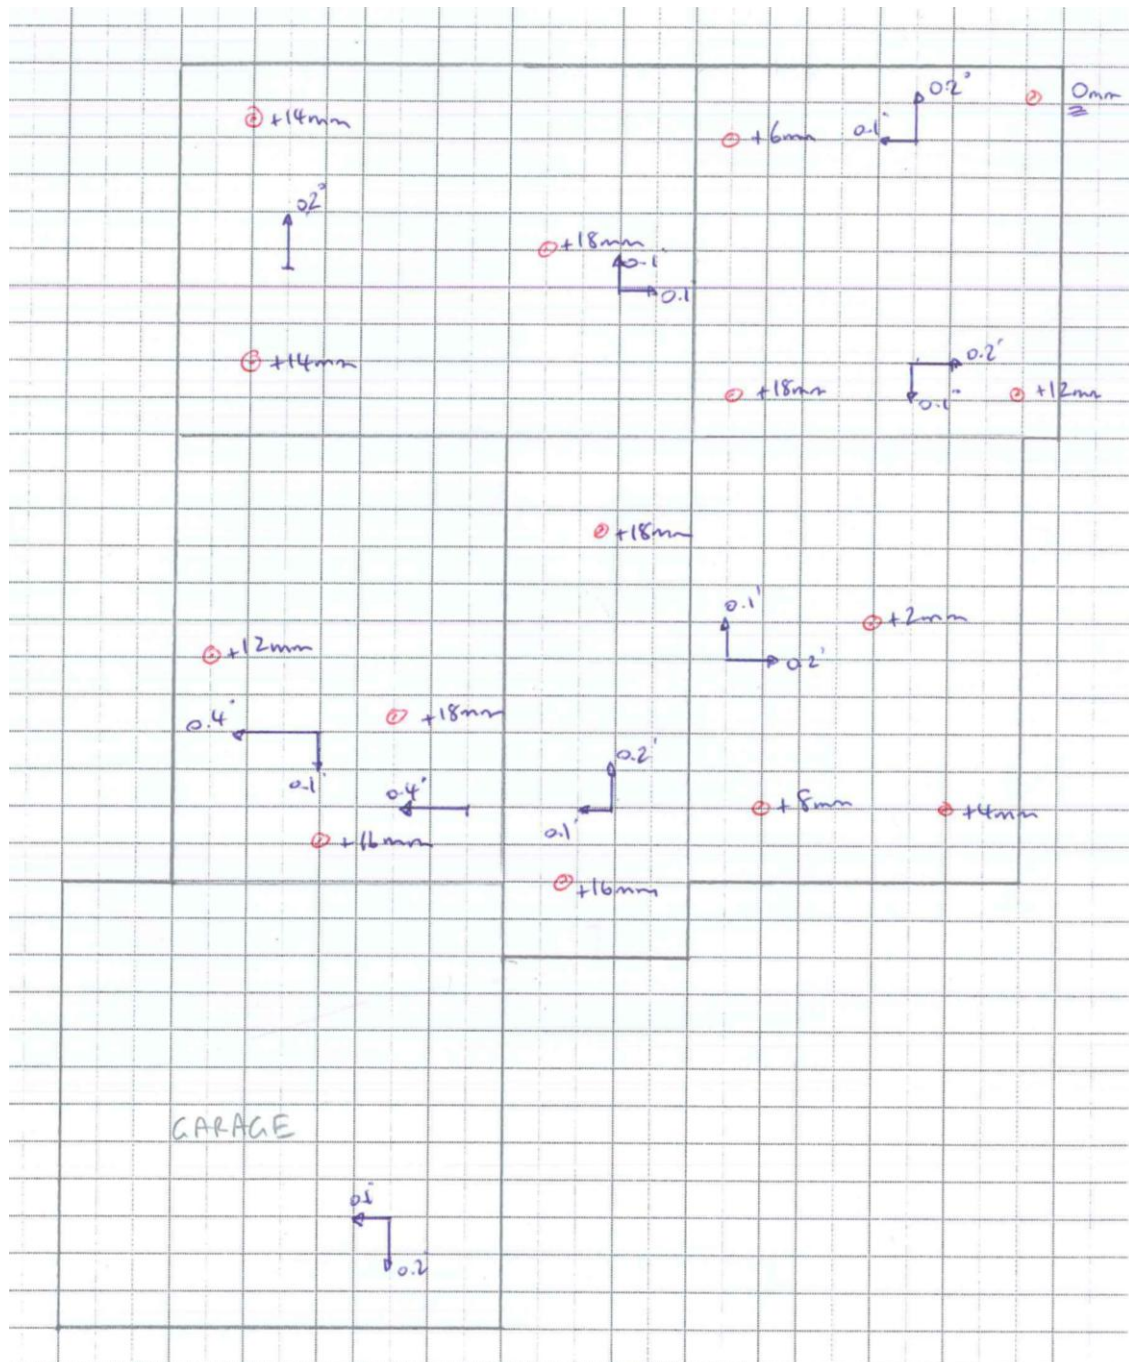
This deformation mode is the next level up from construction tolerances. It is assigned to buildings where the instruments indicate some minor localised tilting, and there is no noticeable uniform tilt direction. These can be 0.1 - 0.4° on the smart-level, and $\pm 20\text{mm}$ on the Zip Level. Houses given this deformation mode are generally given a 'low' damage rating, and show no or low, sometimes moderate damage to their superstructures and foundations. An example floor plan is shown in Figure 4.17.

Figure 4.17. Example floor plan with measurements indicating 'no distinct damage mode'.

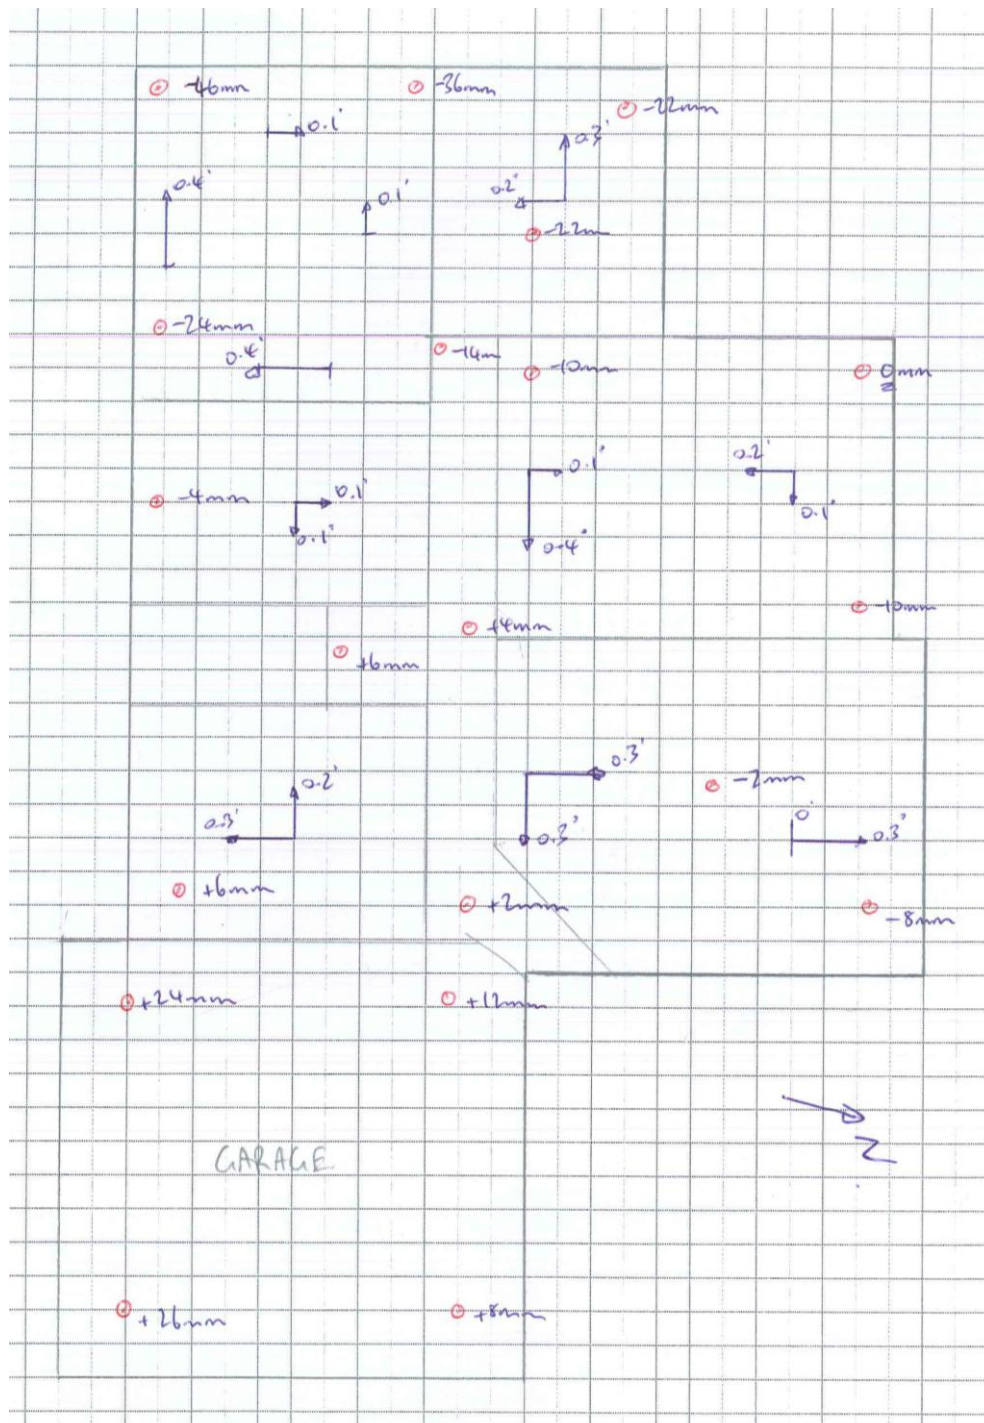
This deformation mode is assigned to foundations with tilting too large to be considered minor, but can't be classed as another more distinctive type of tilting such as uniform, hogging or dishing. Tilt measurements range from 0.1 - 0.7° on the smart-level, and $\pm 50\text{mm}$ on the Zip Level. Buildings with this deformation mode are given low, moderate or high damage ratings and can exhibit low to high levels of superstructure and foundation damage. An example floor plan is shown in Figure 4.18.

Figure 4.18. Example floor plan showing measurements for complex tilting.

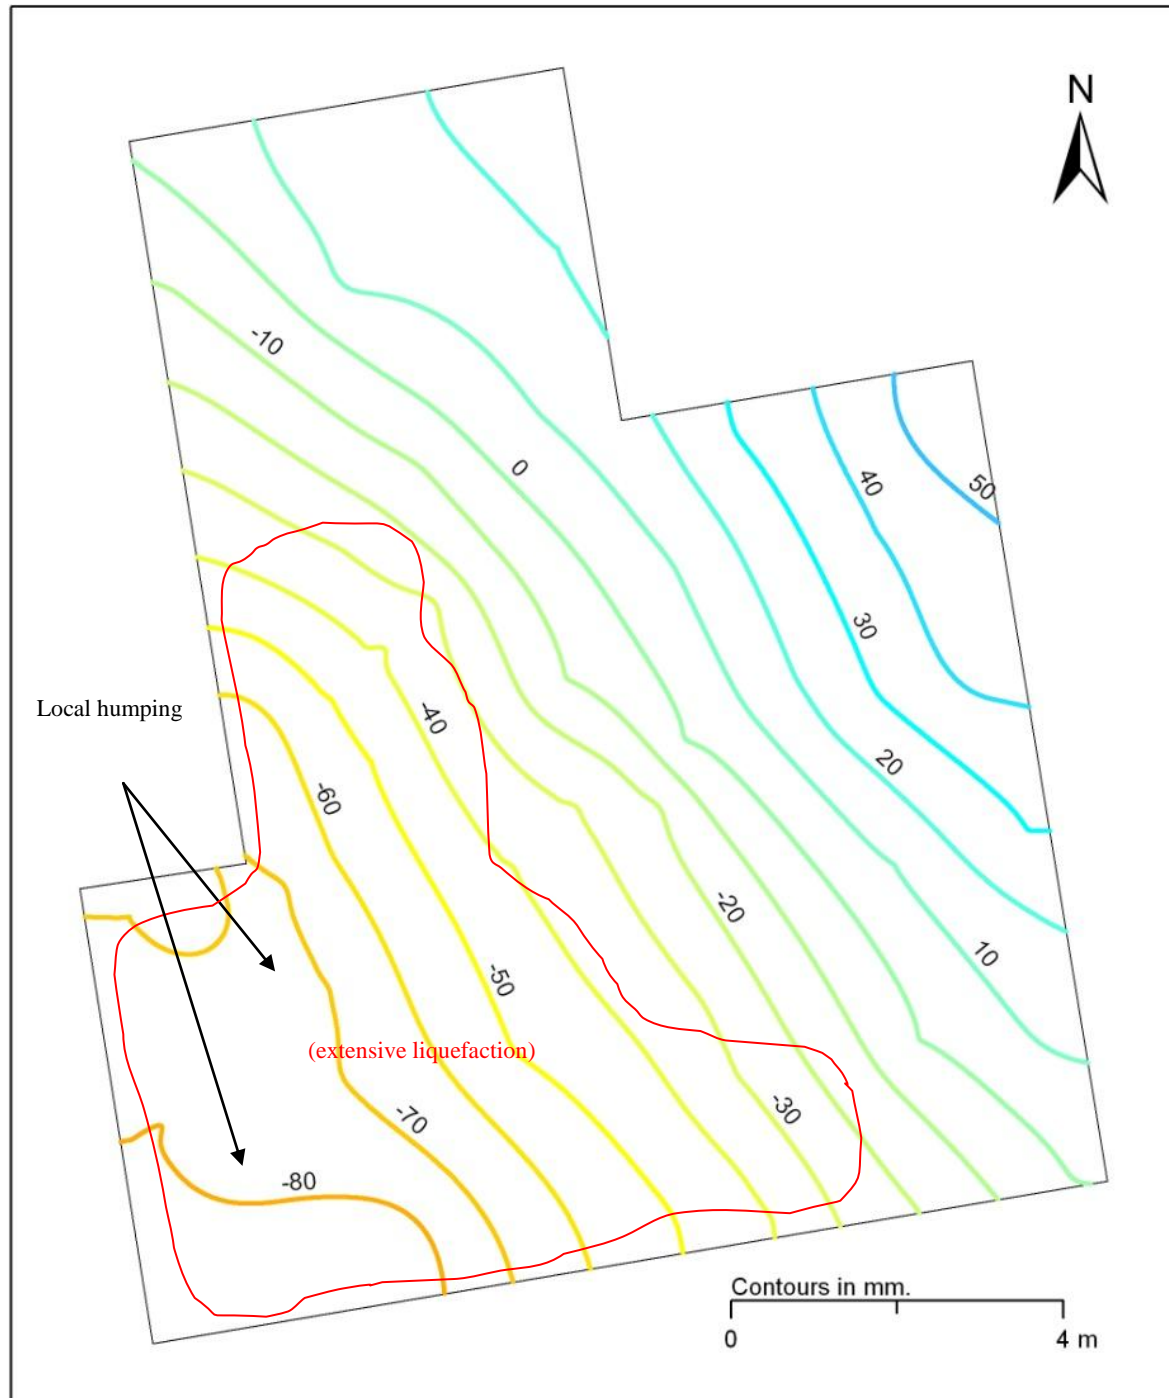
Figure 5.10. House #1 floor plan outline showing floor level contours in 10mm increments, with the area of extensive liquefaction outlined in red.

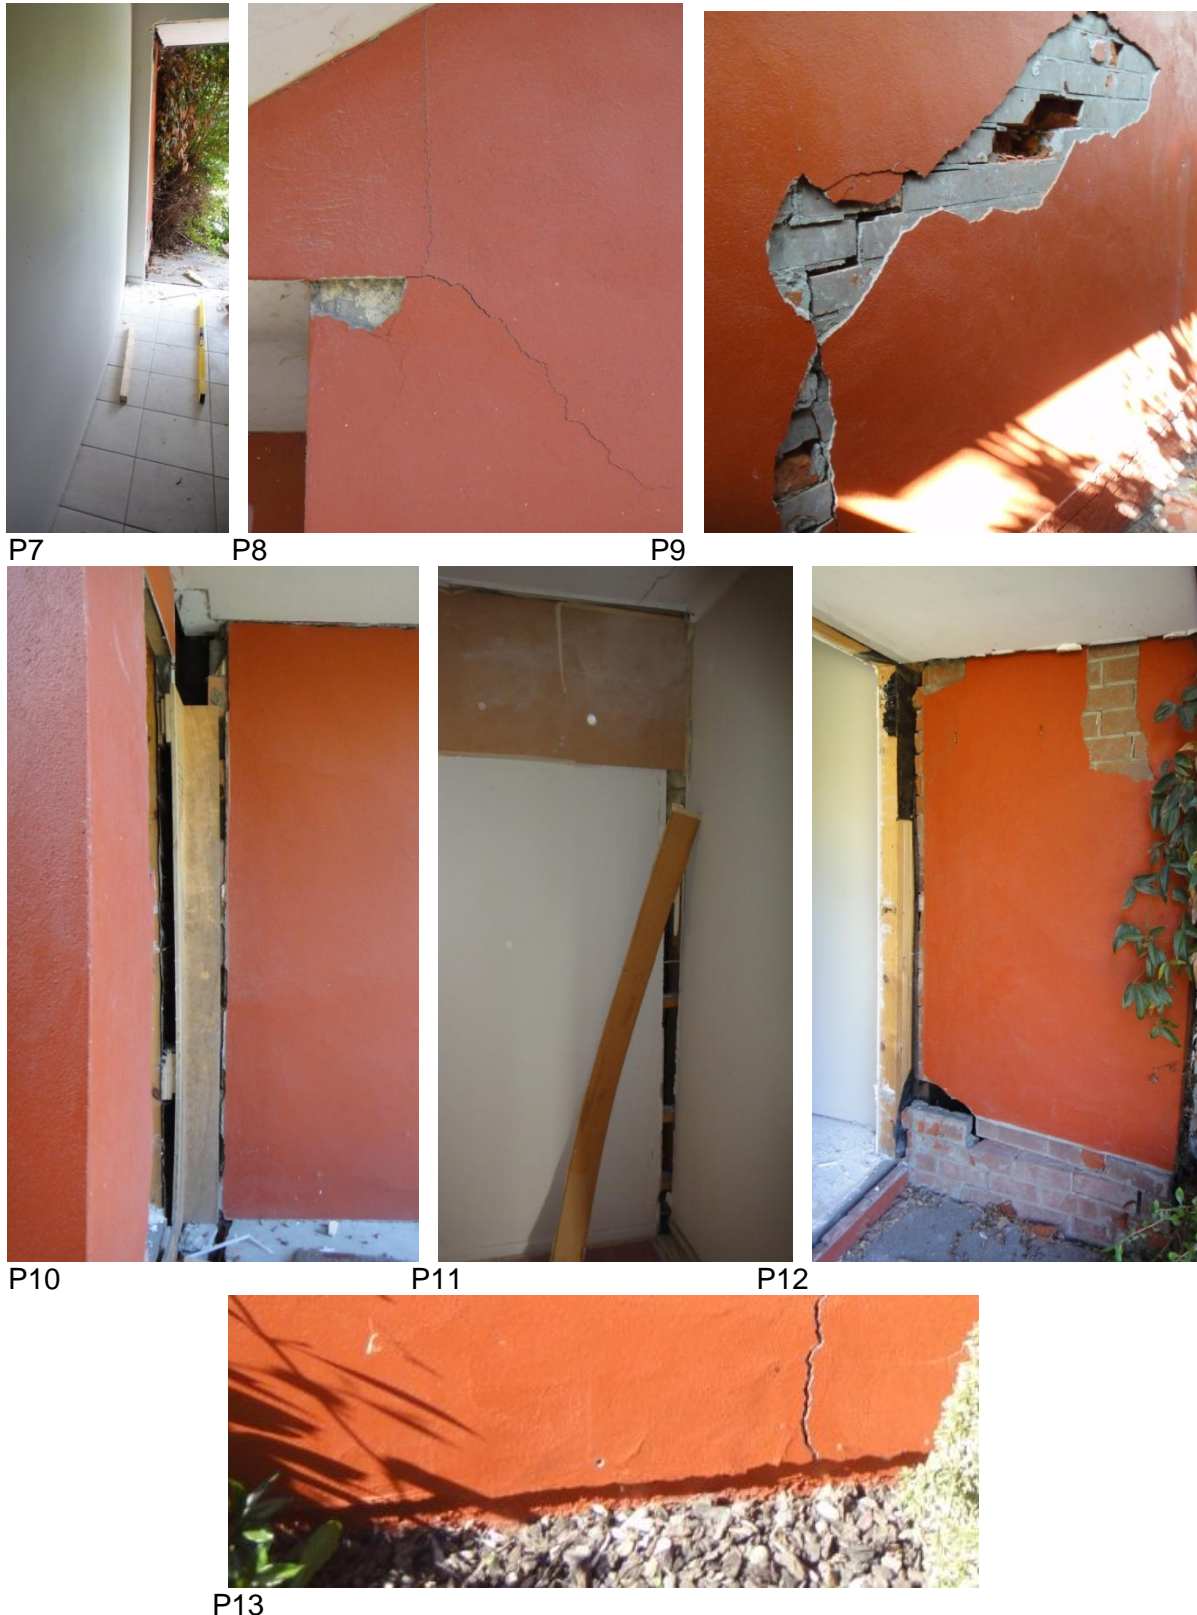
Figure 12. P7: Buckling plasterboard. P8: Minor external cracking. P9: Major diagonal crack in brickwork. P10: South wall exterior structural separation. P11: South wall interior separation. P12: North wall exterior separation. P13: Crack between SE low slab foundation and wall.
